## CWP HEATER TROUBLESHOOTING

When troubleshooting the CWP heater, it is important to diagnose the exact mode of failure as described in this technote so the correct replacement parts can be ordered.

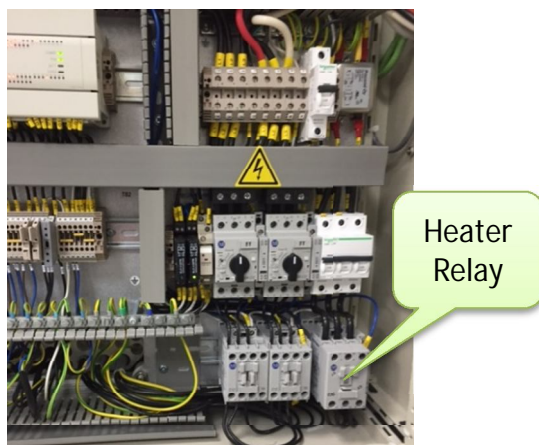
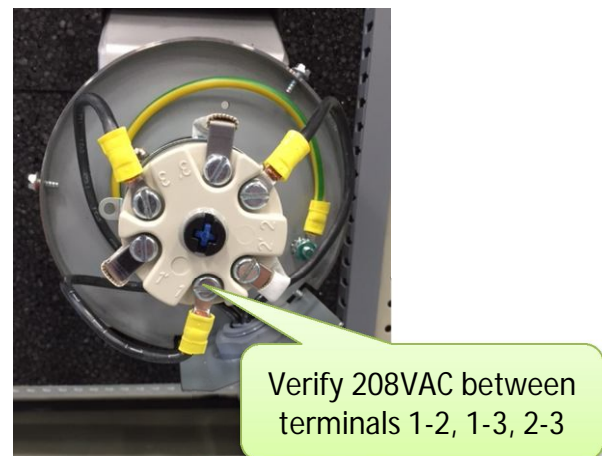
Verify the heater relay is “pulled in”. Verify ~208VAC between terminals 1-2, 1-3, 2-3 on the High Limit Switch, see figures below. If measured voltage is not 208VAC  $\pm 5\%$ , consult an electrician. Turn off high temperature mode.

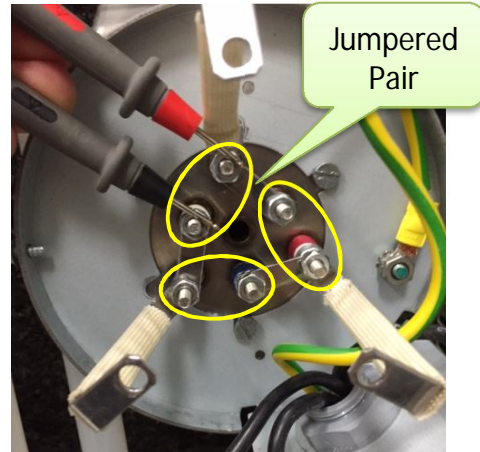
Using an ohmmeter, verify continuity through each of the 3 heater elements. A quick method to verify continuity is to measure the resistance between jumpered pairs, circled in the figure below. The resistance between each jumpered pair should be  $\sim 10\text{-}12\ \Omega$ . If a heating element has failed, order kit WTW602057001.

Note: This continuity check does not isolate and measure resistance across individual heating elements. To double check a failed heating element, remove the jumpers and then check resistances. Per specification resistance of each heating element should be  $15.9\ \Omega \pm 10\%$ .

- Resistance  $\sim 10\text{-}12\ \Omega$  at each of the 3 measurement points means that the heating elements are functional and the root cause of the failure is likely the High Limit Switch.
- If one of the elements has failed the resistance will measure  $\sim 15.5\ \Omega$  across two of the jumpered pairs and  $\sim 30\ \Omega$  across the remaining jumpered pair. If two elements have failed the resistance will be infinite across two of the jumpered pairs and  $\sim 15.5\ \Omega$  across the remaining jumpered pair. If all of the elements have failed, resistance will be infinite across all jumpered pairs.

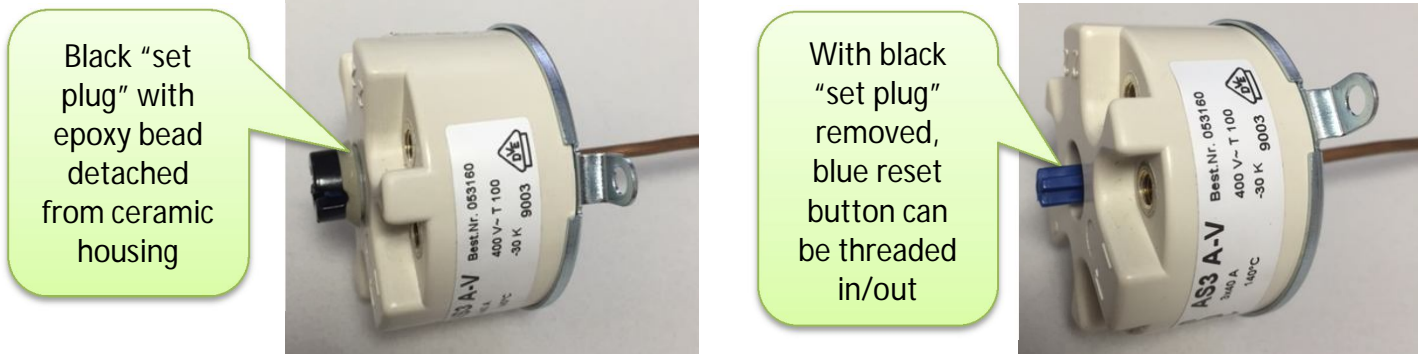
Inspect the epoxy securing the black “set plug” to the High Limit Switch’s ceramic housing, refer to the figures below and HIGH LIMIT SWITCH EPOXY FAILURE DETAIL at the end of this document for details. If the epoxy has released from the housing, order kit 3028896.

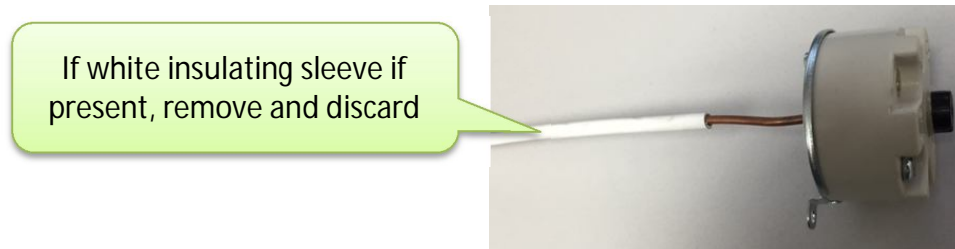
Confirm a white insulating sleeve is not present on the copper probe of the High Limit Switch. If one is present, remove and discard as it is not necessarily and may retain heat, refer to the figure below.

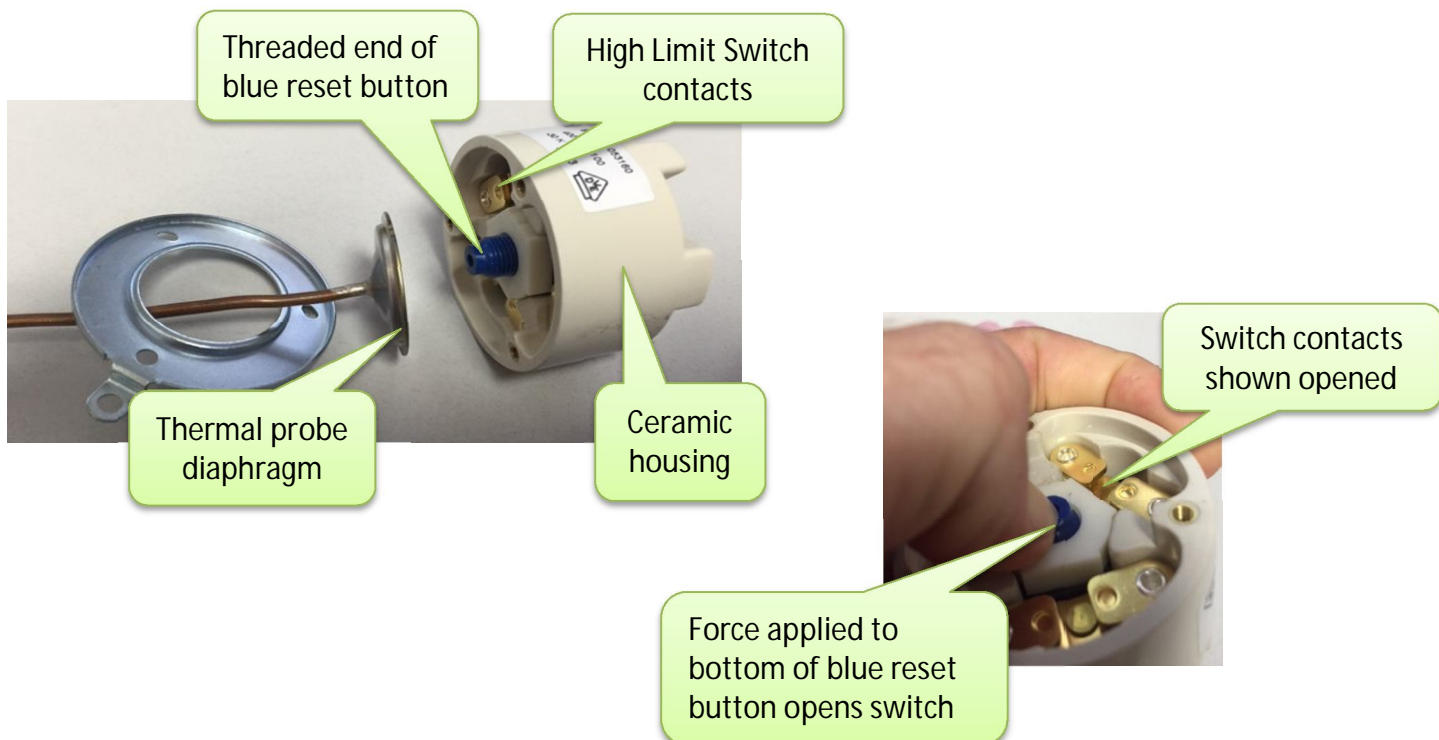
## HIGH LIMIT SWITCH EPOXY FAILURE DETAIL

A bad epoxy seal on the CWP heater's High Limit Switch can present as a heater failure. The manufacturer is now using an improved epoxy process starting with heater lot number 1340332. The reset button is held in position by a "set plug" which is the component directly epoxied to the High Limit Switch's ceramic housing. If the epoxy fails, the "set plug" no longer secures the reset button, see figures on pg 3.

The blue reset button has a threaded connection at switch assembly. If the reset button is turned clockwise after an epoxy failure, it is forced against the diagram of the thermal probe in the switch assembly. This then pushes the switch contacts apart and opens the heater circuit as if the High Limit Switch has tripped.
